UNITED STATES DEPARTMENT OF THE INTERIOR
NATIONAL PARK SERVICENATIONAL REGISTER OF HISTORIC PLACES
INVENTORY -- NOMINATION FORM

The Cloisters

The Parker Estate

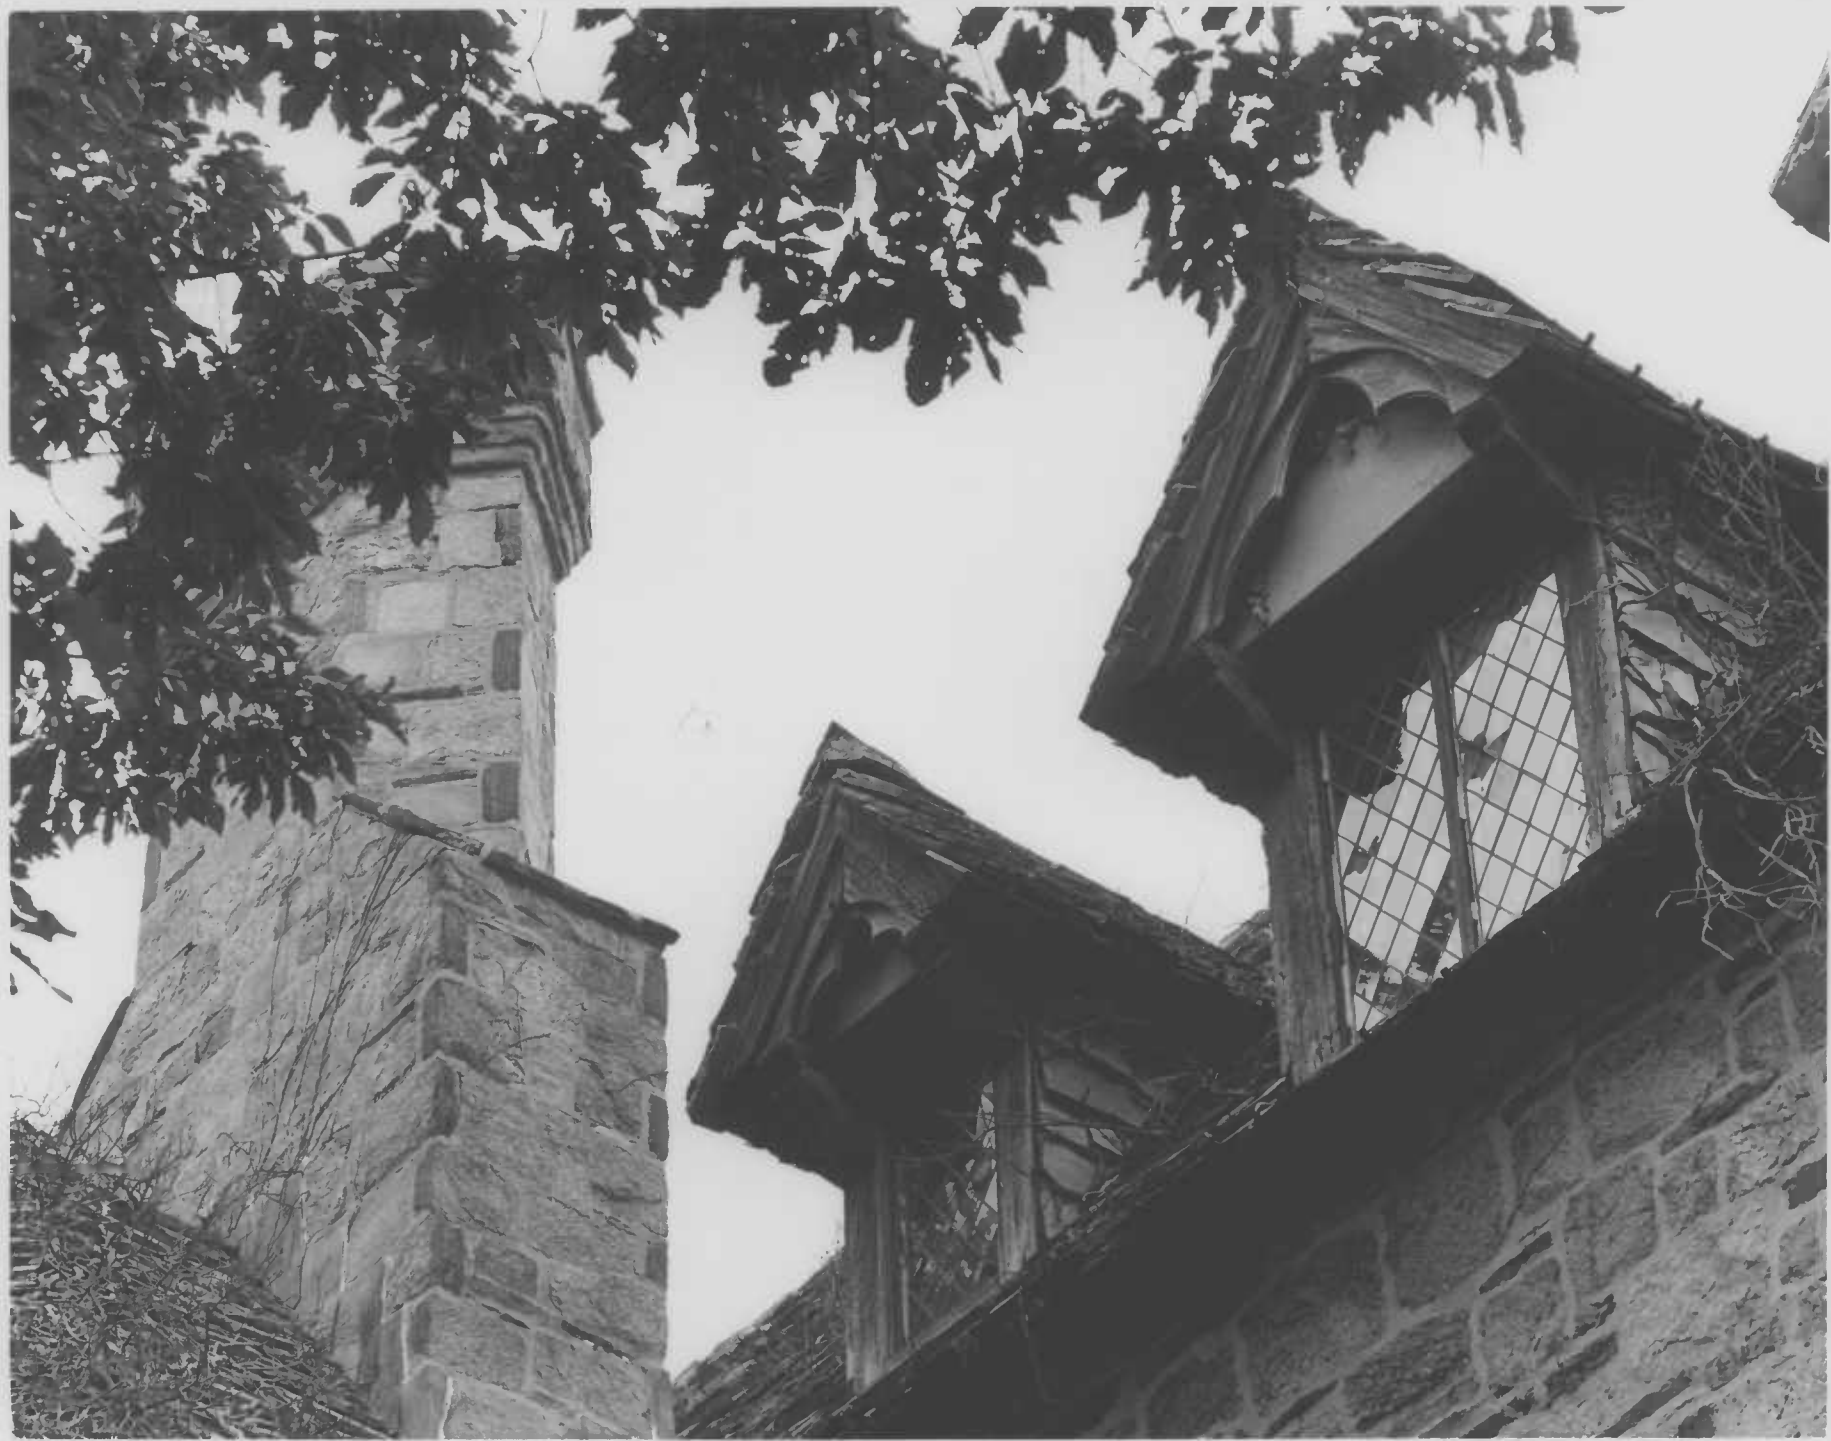
12

East Facade - Detail

The east facade is the most plain, and appears the most massive, with the main block rising to a height of four stories from the basement level. The pitched roof is broken at left by one large, hexagonal chimney with a heavy molded cap. To the right of the chimney, three small adjoining dormer windows are decorated with elaborate Gothic wooden pediments. The principal feature of the east facade is a very large, hexagonal porch with pointed stone roof which rises two and one-half stories above the open carport on which it rests. The tall windows have narrow vertical sections filled with wooden Gothic tracery from the renowned Baltimore Gothic Revival mansion, Glen Ellen, designed by A. J. Davis. To the right beyond the massive central section of the east facade is a large, single story garage with two wide, wooden doors. Stone steps with a wrought iron railing lead up from the left of the garage to a battlemented terrace on top of it.

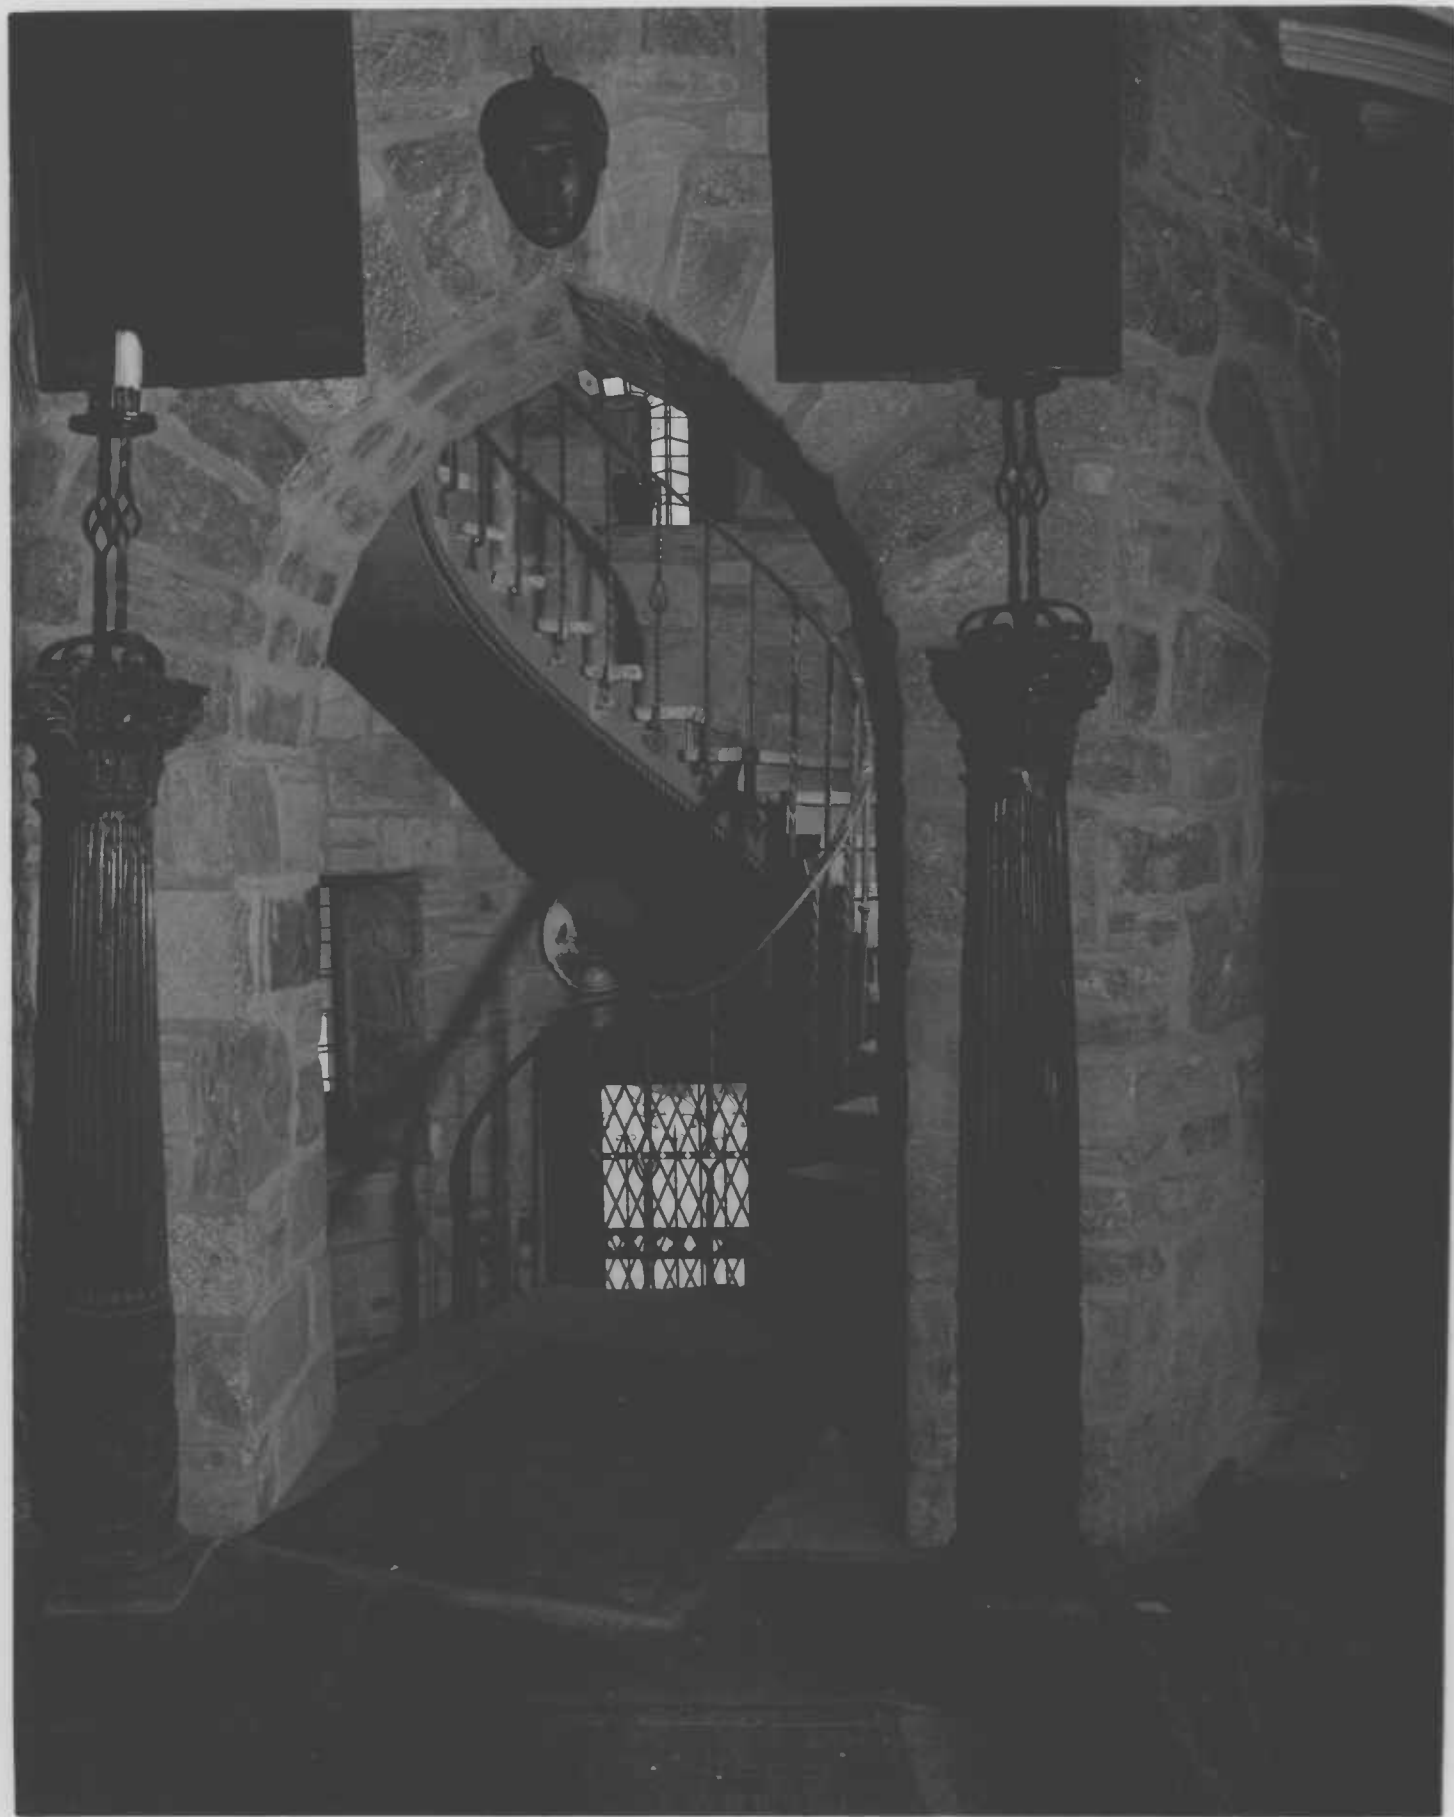
BA-1182 (17)
The Cloisters
Balto. Co.
Entrance Hall - North side -
stair tower

At the north end of the entrance hall is the octagonal stone stair tower which opens onto the hall through three Gothic pointed arches, approximately eight feet tall. The central arch leads onto the spiral staircase of heavy concrete steps that climbs from the basement to the third floor. The stair railing is wrought iron supported by iron balusters in a variety of twisted and pierced designs.

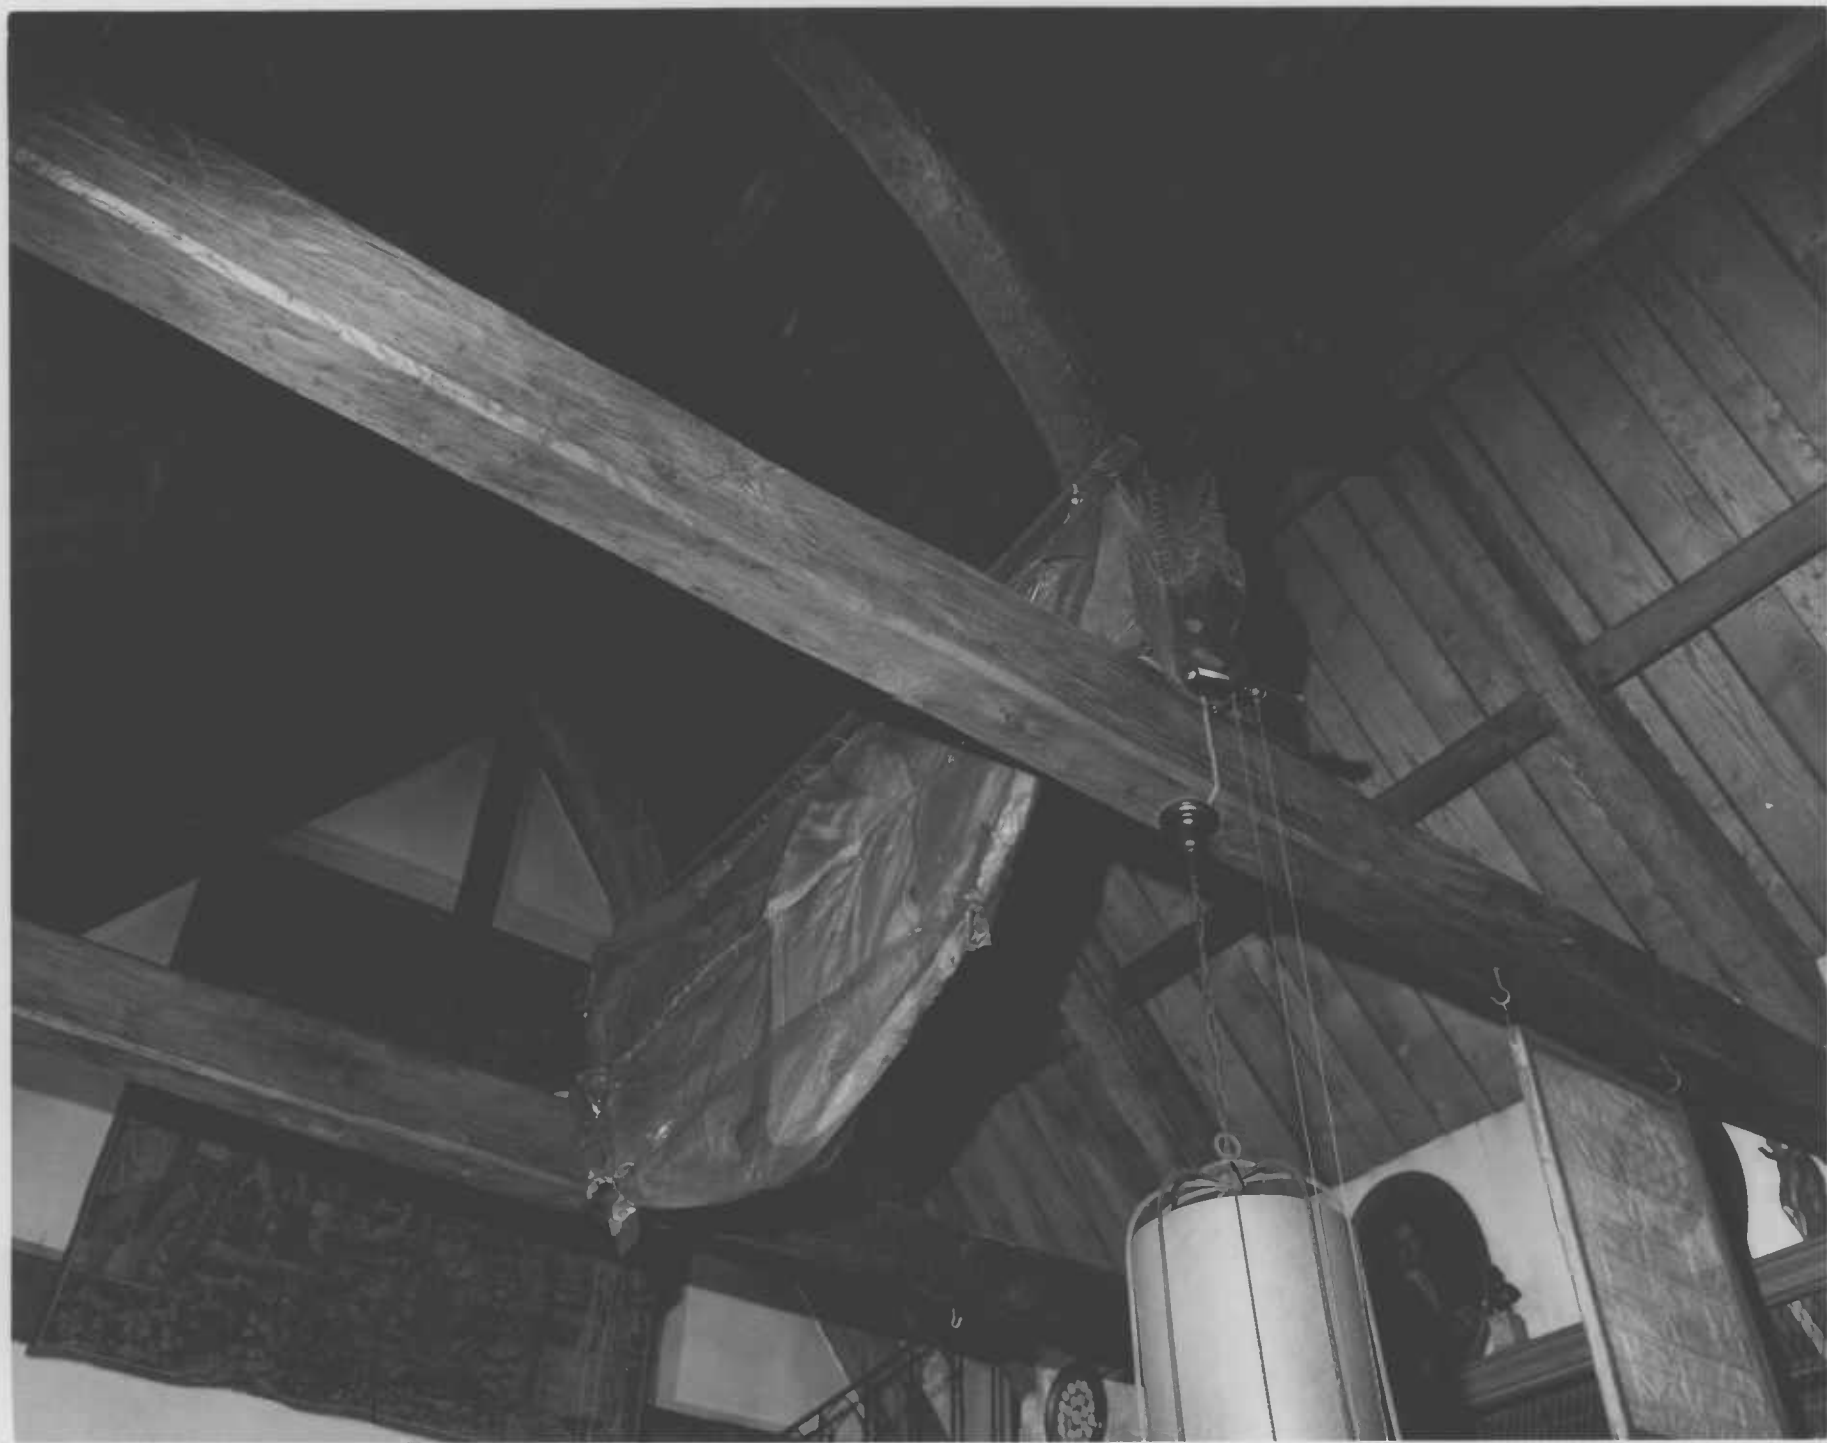
(24)

Library- Detail of Ceiling

The library likewise has a steeply gabled, exposed beam ceiling which rises to a height of two full stories. Two curved diagonal braces and a central stud rest on each of the two exposed massive summer beams. Other notable pieces of woodwork in the room are the tall bookcases which cover most of the east and west walls. The molded columns between the shelves pull out on tracks to reveal ladders. On the north wall is a stairway with wrought iron railing and balusters in a simple, Gothic-style design. On the south wall is a large window and a Gothic-style door leading onto a small porch that once was glazed on the south side, but has now been plastered to give a half-timbered effect.
